MARINE INVESTIGATION REPORT
M06L0004

FIRE

GENERAL CARGO SHIP *SKALVA*
GASPÉ, QUEBEC
04 JANUARY 2006

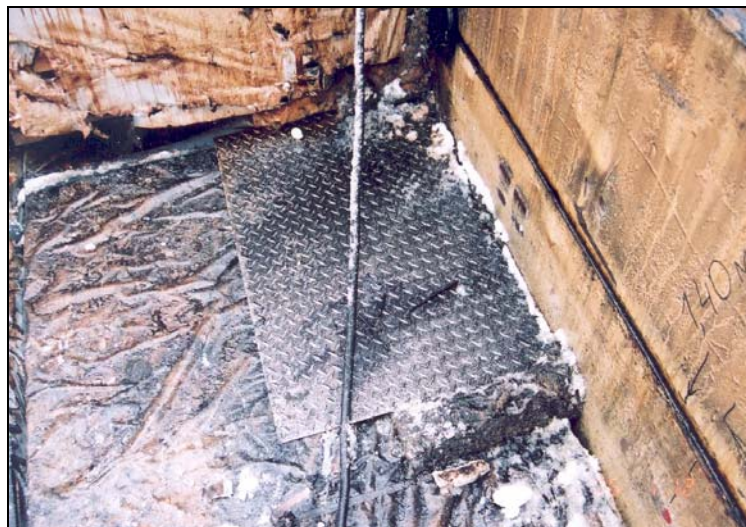
The welder placed an aluminum plate measuring 60 cm by 40 cm on the wood bundle beneath the welding area to protect the cargo (see Photo 2). Mineral wool batt insulation was used to fill void space between the bundles, and two fire hoses and a dry-chemical fire extinguisher were positioned nearby.

Photo 2. Hatch coaming and aluminum plate on top of a wood bundle adjacent to the welding area

Without the benefit of a comprehensive risk assessment, the hazards associated with hot work may go unnoticed and fire-prevention measures may be inadequate. In this occurrence, the guarding used to confine the spills and slag and protect the wood cargo was insufficient. Additionally, no dedicated fire watch was maintained.

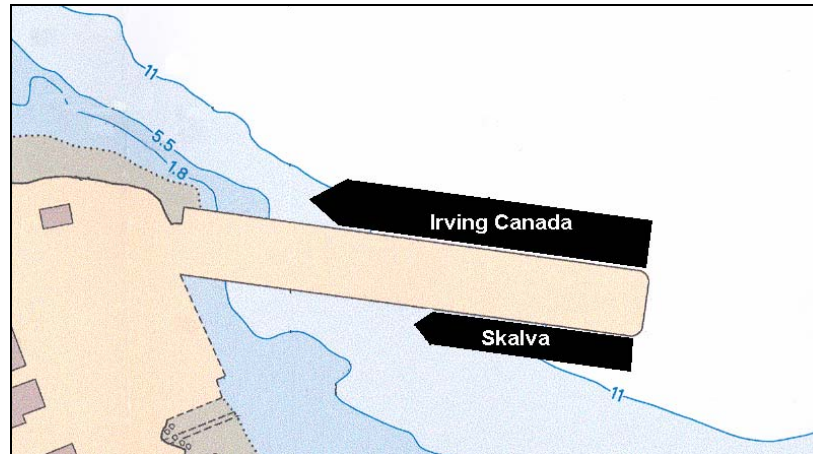
During the cooling-off period of 04 to 11 January 2006, with cargo hatches closed following the CO₂ discharge into the hold, the tanker *Irving Canada* arrived at the port to discharge a cargo of gasoline and diesel products. On 06 January 2006, the tanker *Irving Canada* requested to tie up to the north side of the public wharf, 35 m from the *Skalva* on the south side, but the request was refused by TC Harbour Operations in consultation with TC Marine Safety.

Figure 1. The cargo ship *Skalva* and the tanker *Irving Canada* at the Gaspé wharf

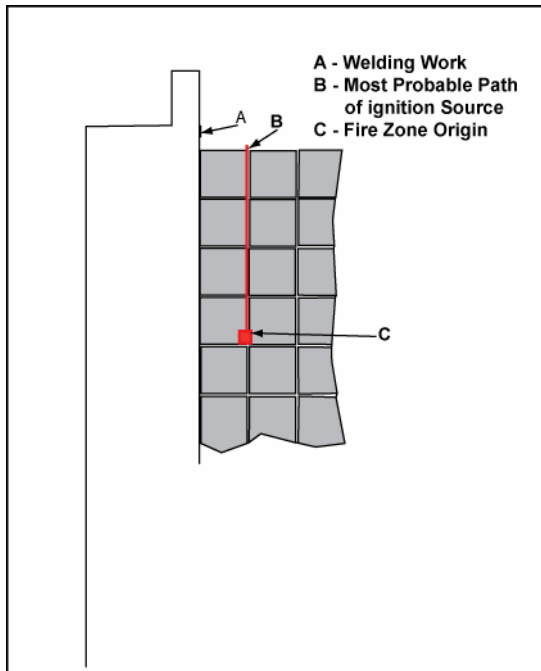
When the hold was opened after the fire, an assessment showed that the wood bundles in the vicinity of the welding work had been destroyed by a smoldering, slow-burning yet intense fire. Burn patterns indicated that the fire originated from beneath the top bundles and inboard from the first row of bundles along the port side. Bundles were systematically lifted out of the cargo hold in an effort to determine the seat and cause of the fire. After four tiers of bundles were removed, burn patterns suggested that the seat of the fire had been near the gap between the first and second rows on the port side, four tiers down from the top (see Figure 2 and Photo 3). Carbonized wood and ashes were examined in that vicinity, but no indications were found as to the source of ignition.

Figure 2. Cross-section view (not to scale)

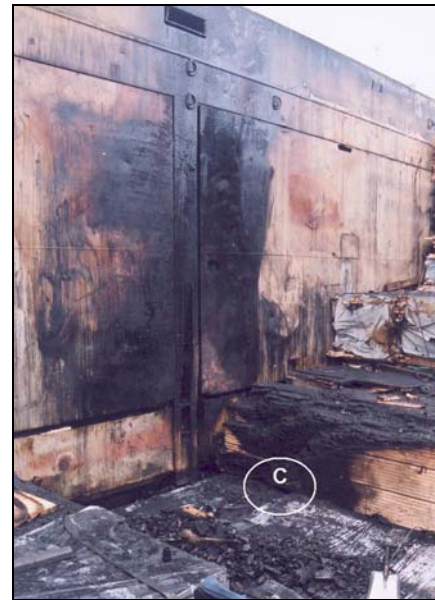
Photo 3. Fire zone origin

Ignition sources were present within the hold of the *Skalva*, which had been loaded with a combustible cargo of dry softwood lumber. The void space between the bundles that were inboard of the first row and adjacent to the hatch coaming was not blocked, and fire-retardant blankets were not used to cover the bulk wood cargo nearby. Both smoking and welding in the hold considerably increased the risk of fire. However, given the sequence of events, the proximity of the welding work to the fire zone origin, as well as the zone's depth (four bundle tiers down), there is a high probability that hot welding by-products ignited the fire.
